# Typical 8 Harness Satin Double Cloth With Stitching Points

# Stress Strain Curves

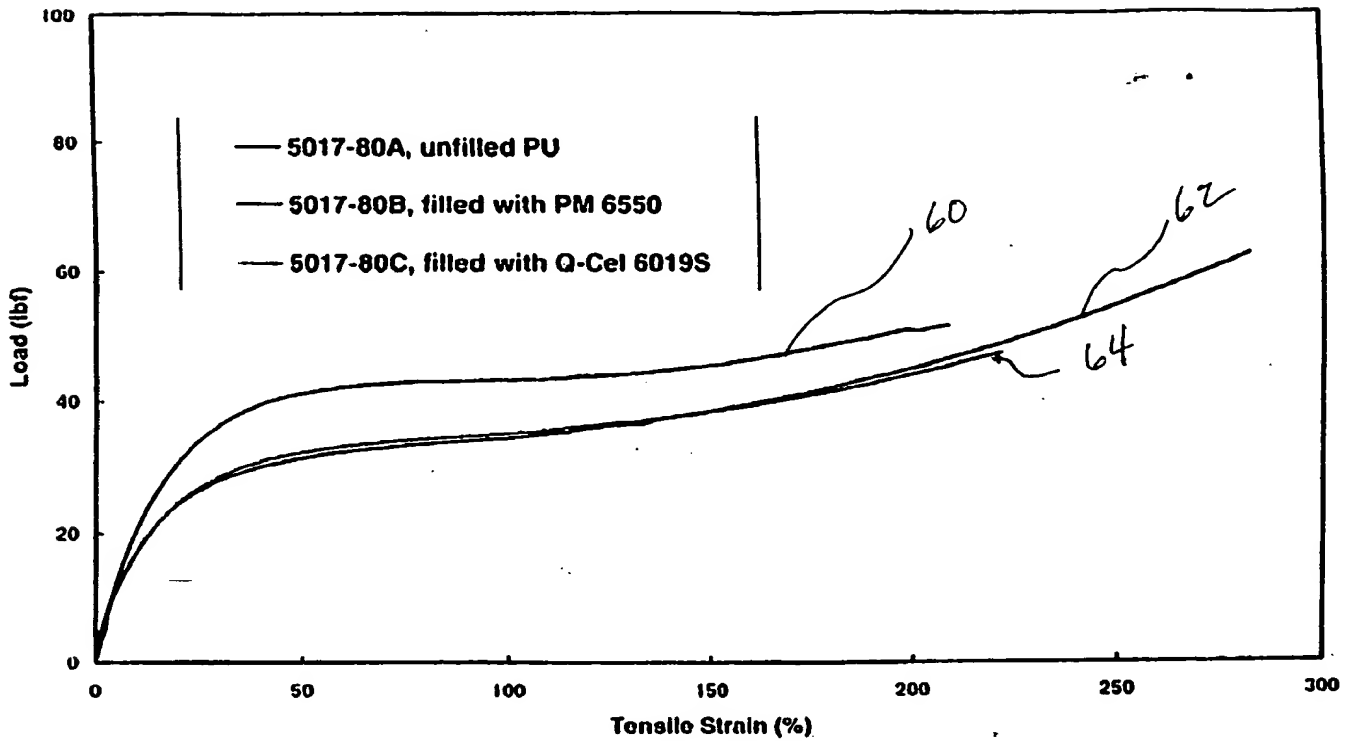
Figure - Stress - Strain Results

## Comparison of Filled PU vs. Unfilled
